OPAL TOWER INVESTIGATION FINAL REPORT

**Independent Advice to
NSW Minister for Planning and Housing**

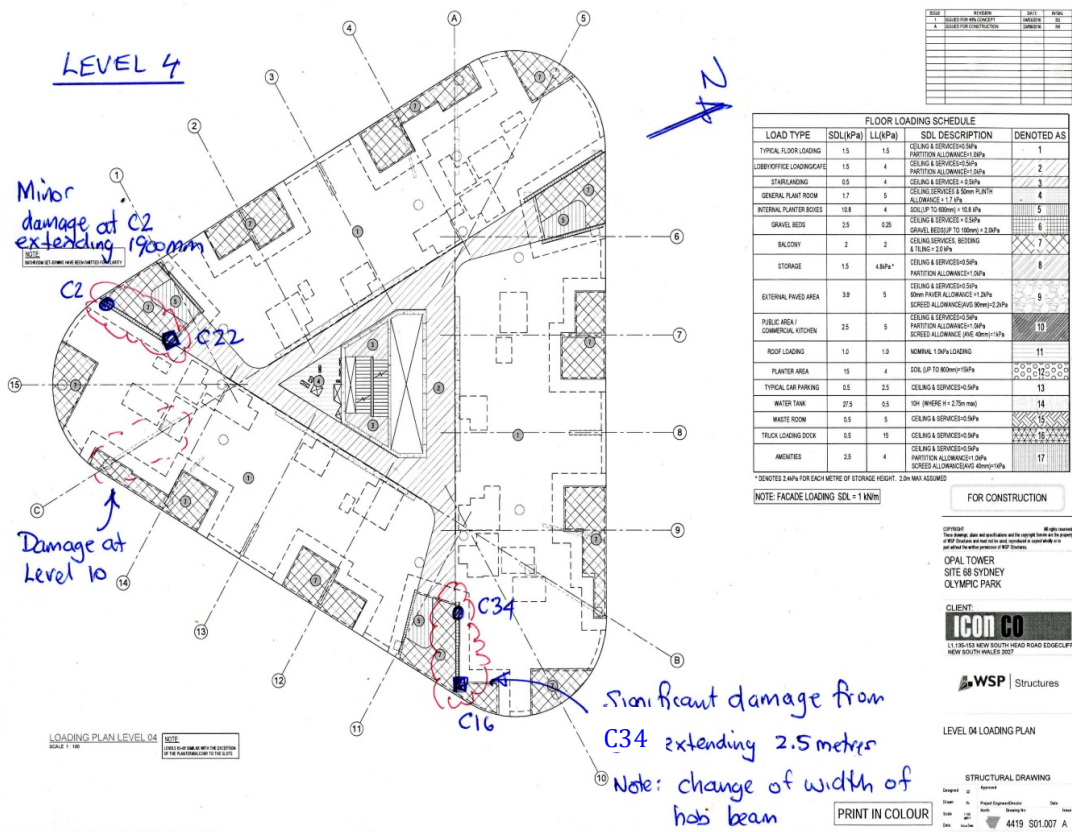
Figure 3. Plan view indicating locations of damage observed on Level 4

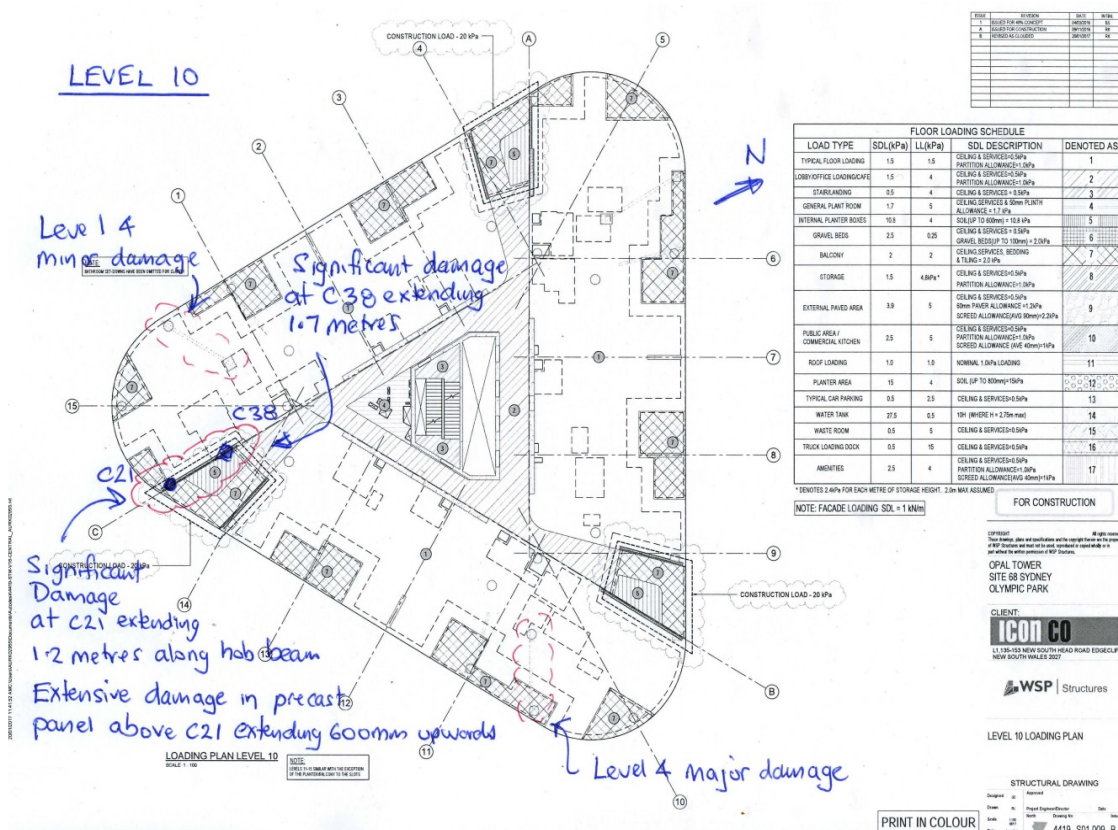
Figure 4. Plan view indicating locations of damage observed on Level 10

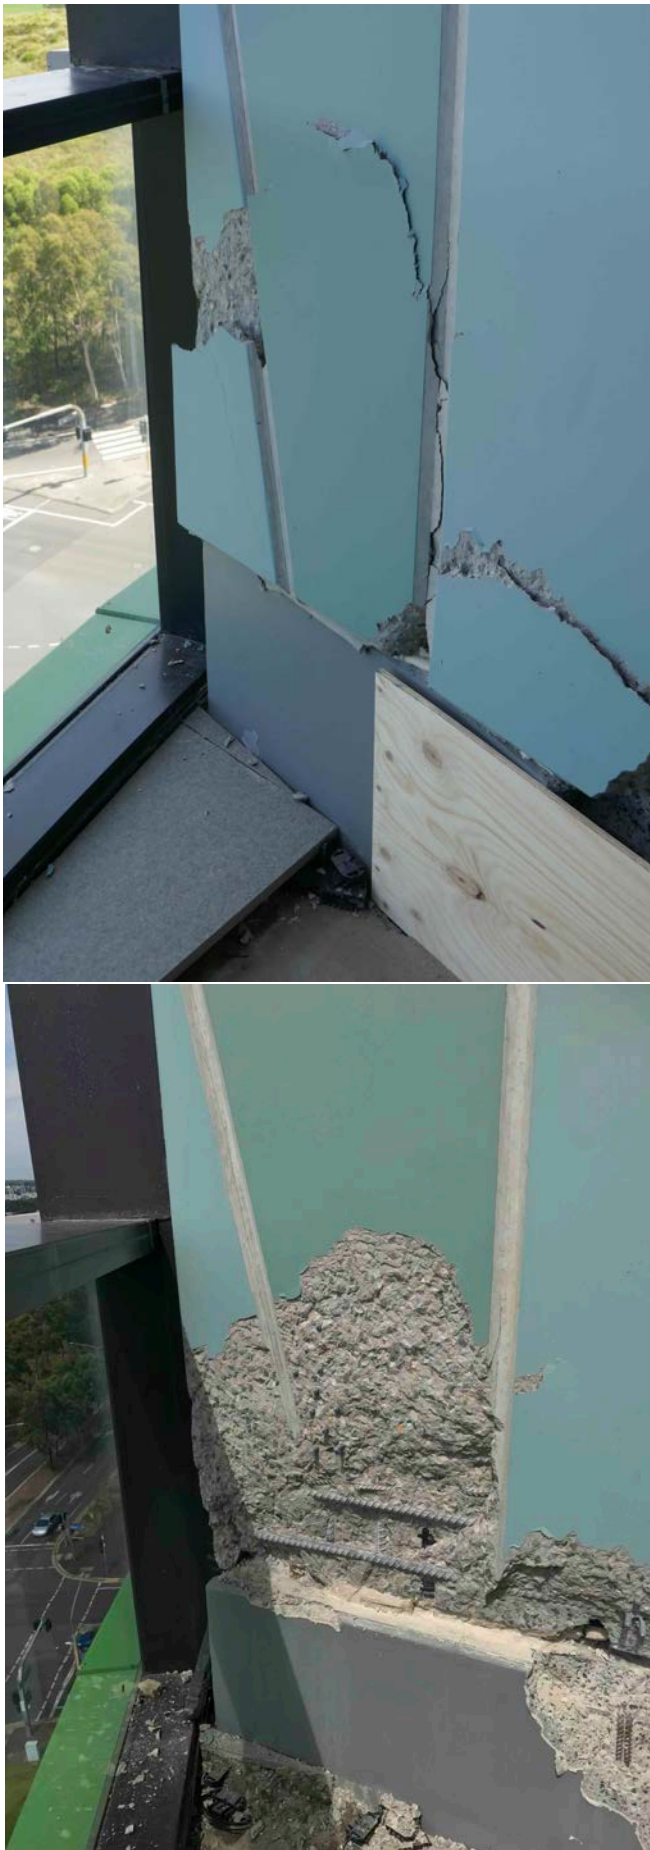
Figure 5. Damaged precast Panel A at Level 10 above column C21, before (top) and after (bottom) broken section of concrete removed.

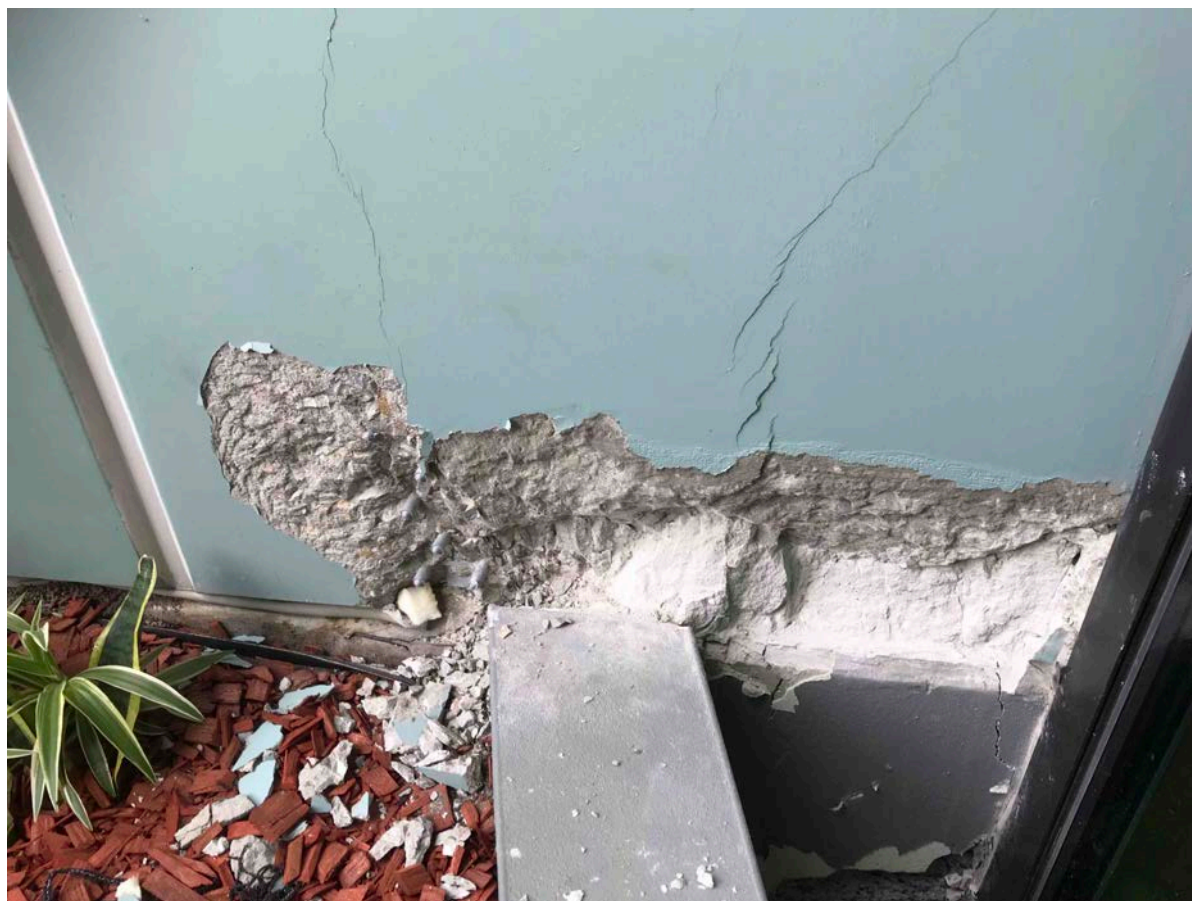
Figure 6. Damaged precast Panel A at Level 10 above column C38, after some broken sections of concrete removed.

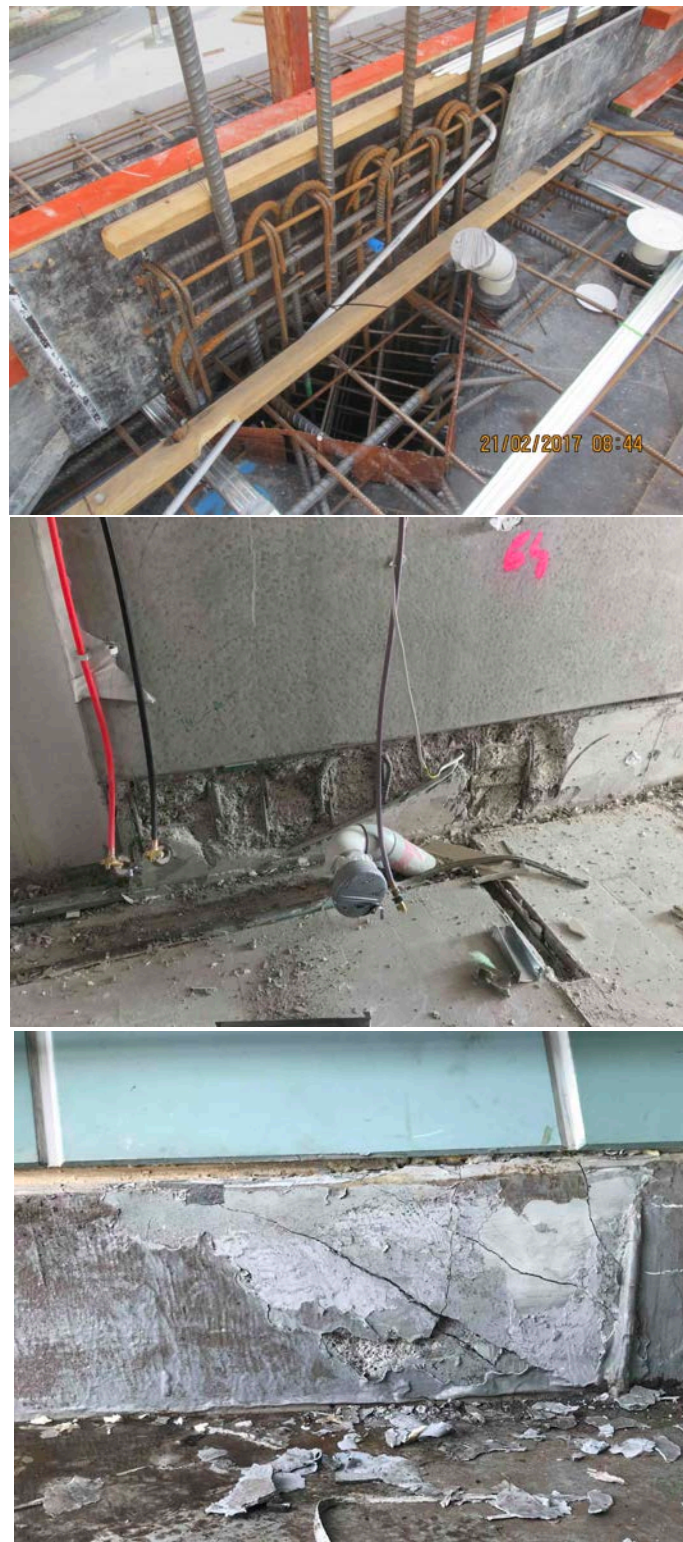
Figure 7. Photographs of the hob beam in the vicinity of column 38 at level 10, prior to pouring concrete (top photo), inside the building on 8 January 2019 after cracked concrete cover removed (middle), and outside on 8 January 2019 after the garden and waterproof covering removed (bottom). Note the positioning of the reinforcing bars, the encroachment of the column bars into the cover zone, the lack of anchorage of some horizontal bars, and the encroachment of a conduit into the concrete cover zone. The vertical dowel bars that engage with the precast concrete panels can also be seen in the top photograph.

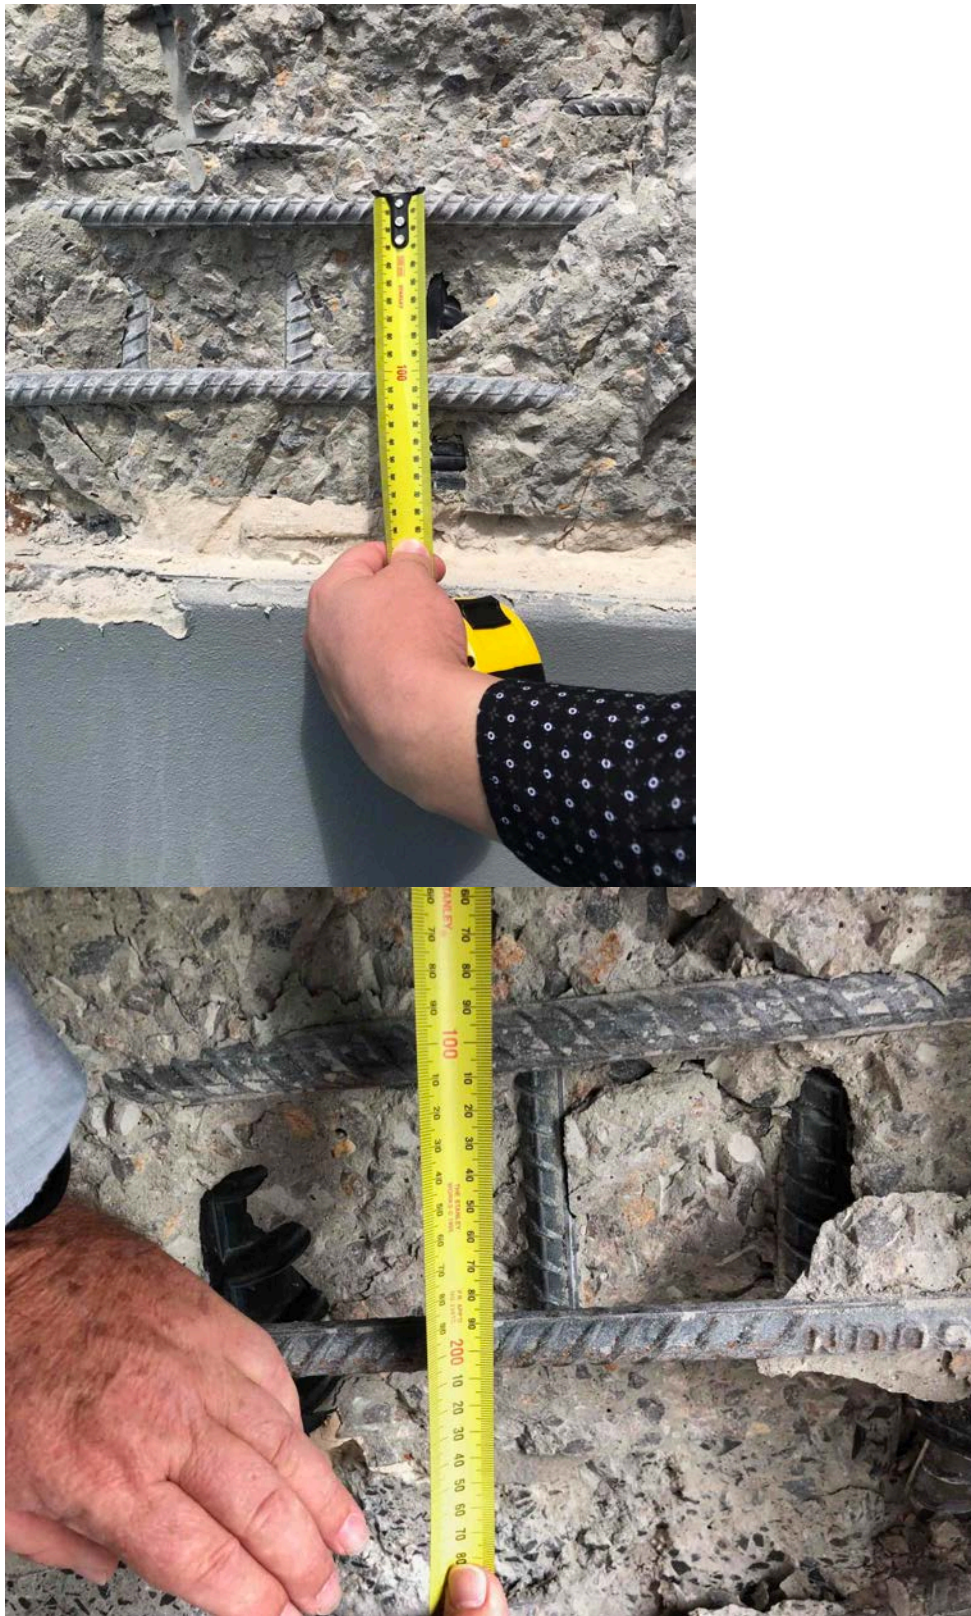
Figure 8. Photographs of the outside (top) and inside (bottom) of panel A at Level 10 just above hob beam adjacent to column 21, indicating N20 reinforcing bars at 100 mm centres in the lower portion of the precast panel. Note the exposed grout between panel A and the hob beam and the black plastic sheath for the joining dowel (top photo, right of tape measure).

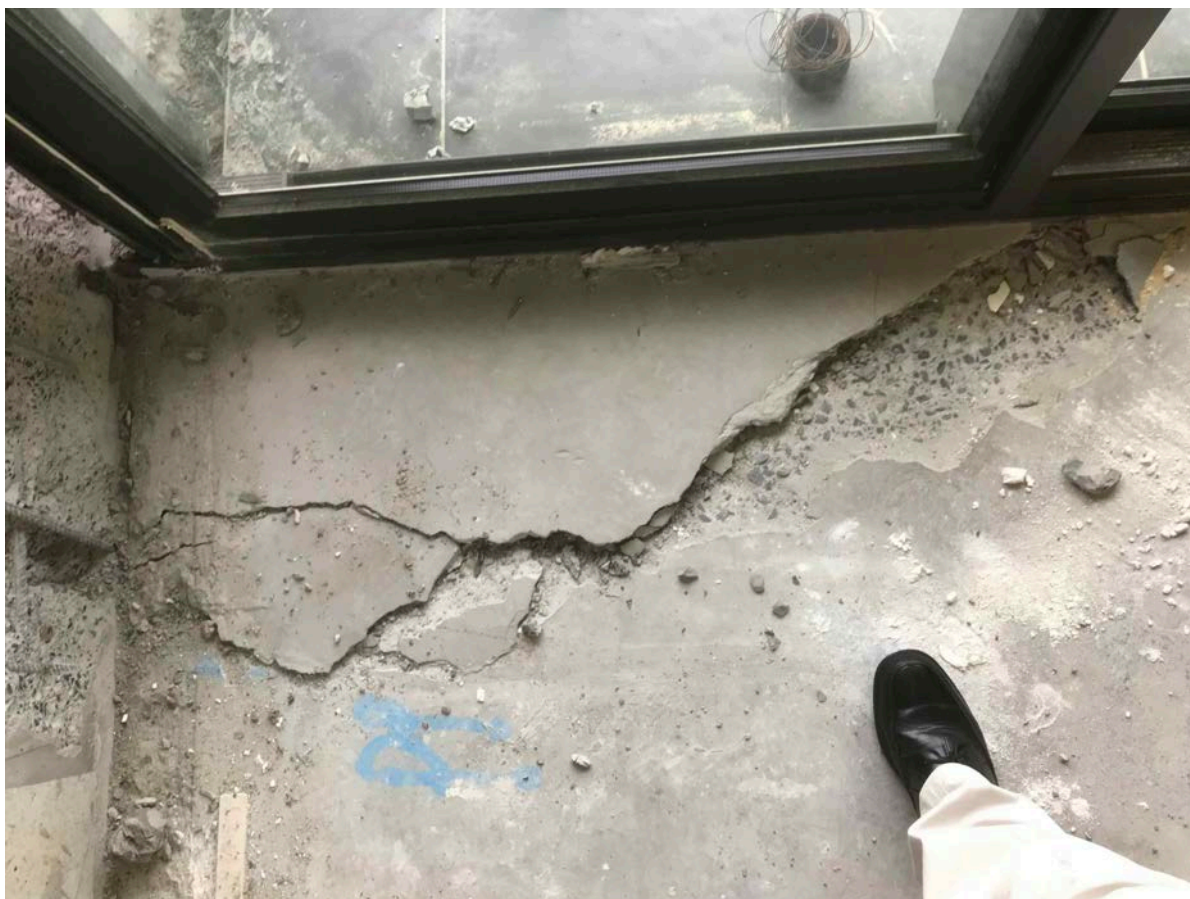
Figure 9. Photographs of the damaged floor slab adjacent to column C21 on Level 10.

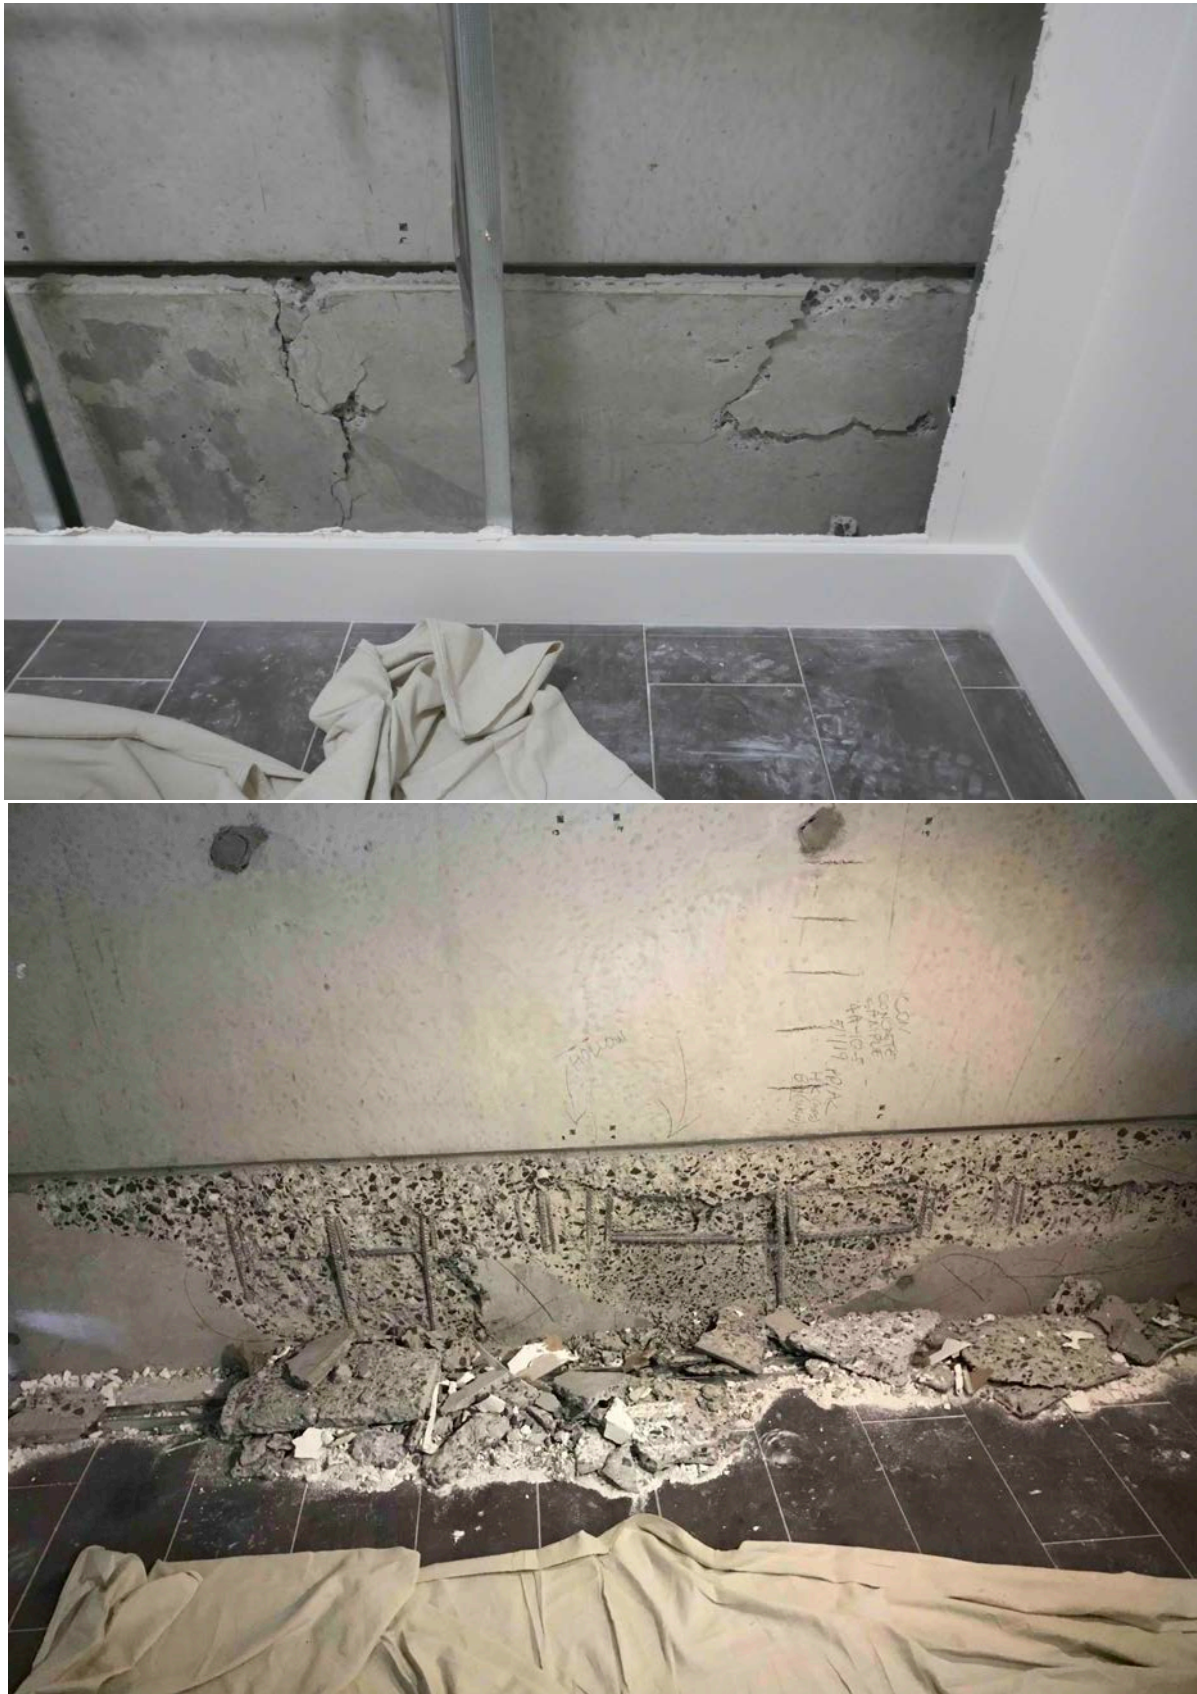
Figure 10. Photographs of the damaged hob beam on Level 4 near column C34 before (top) and after (bottom) cracked concrete removed.

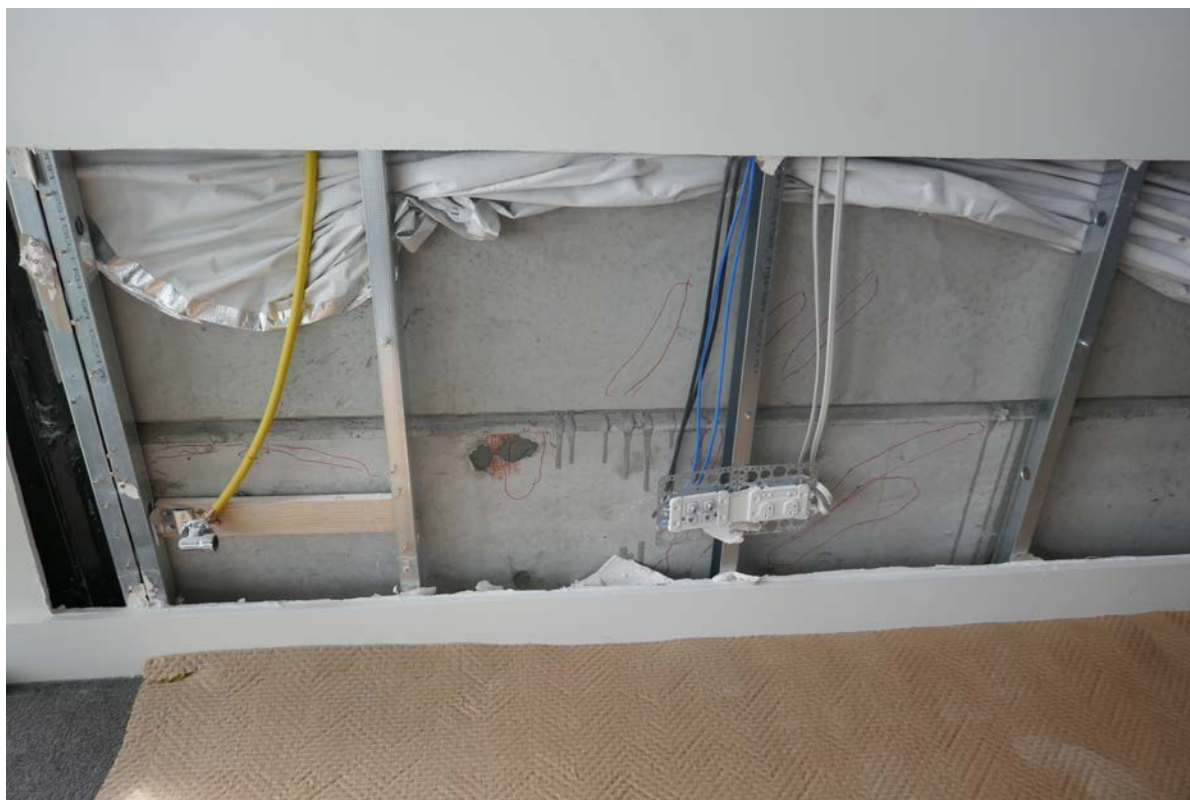
Figure 11. Photograph of the hob beam and panel on Level 4 near column C2 with red lines indicating minor cracking.

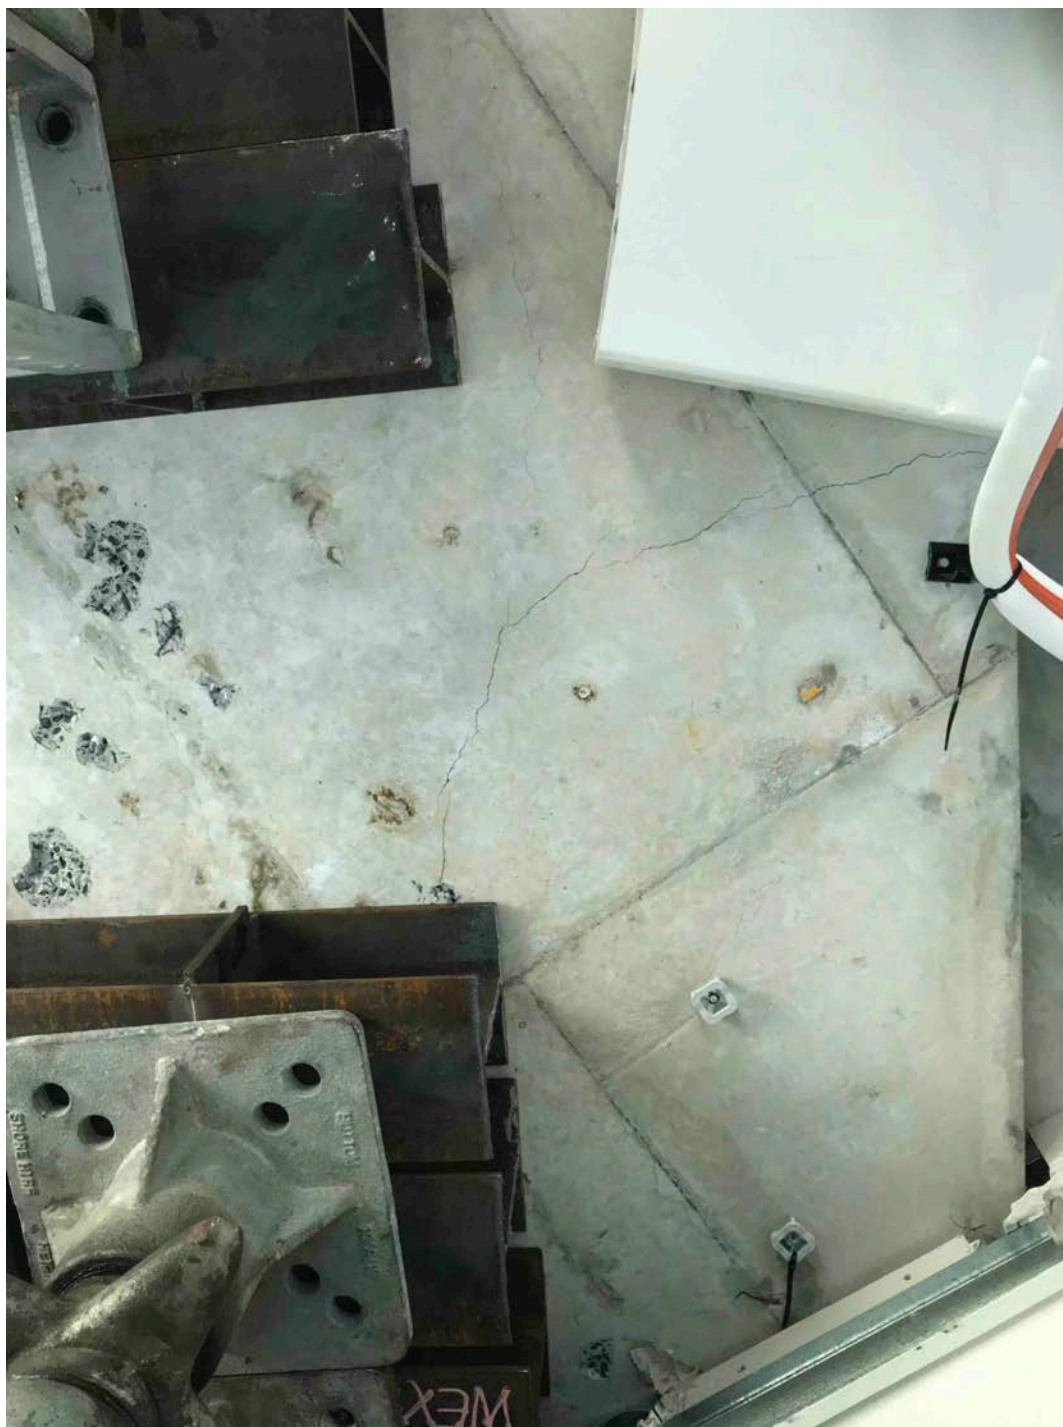
Figure 12. Photograph of a crack in the floor plate between Levels 3 and 4.

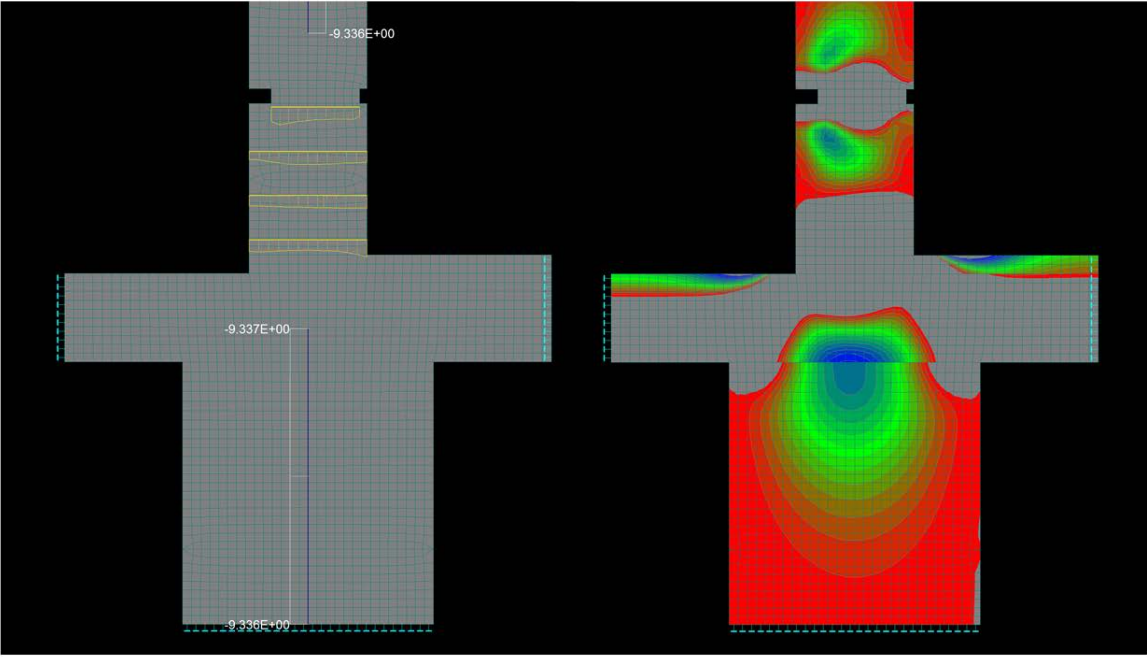
Figure 13. Typical distributions of axial stresses acting on the hob-beam (left) and tensile bursting stresses (right) – Level 4 Grid Line A.

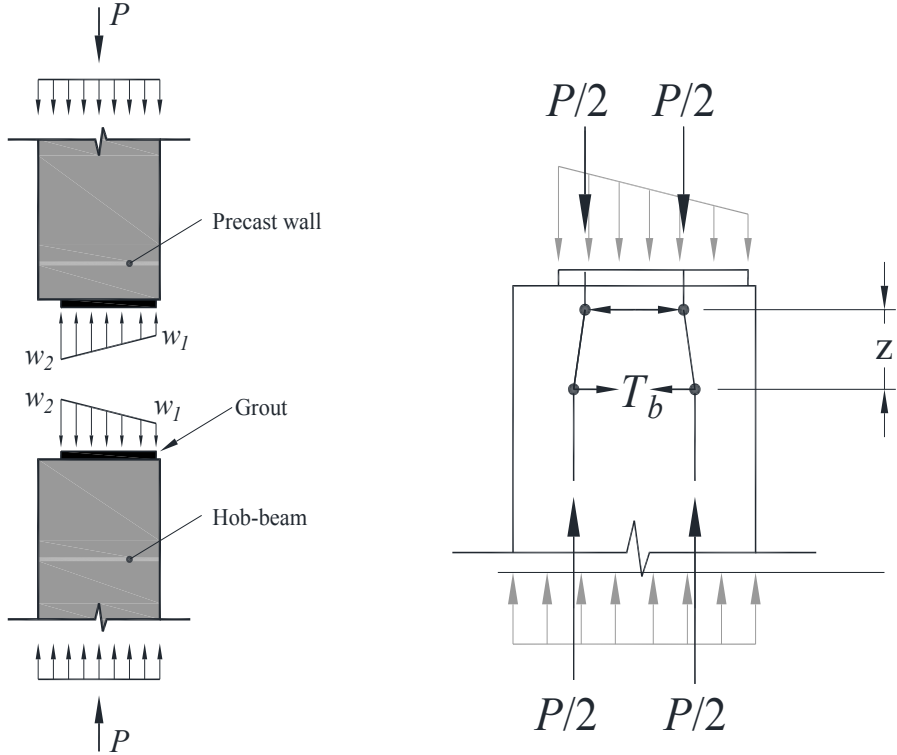
Figure 14. Schematic representation of axial forces and stresses passing through the wall panel to hob-beam grouted connection (left), and strut-and-tie model describing bursting forces that result from the disturbance caused by the joint’s geometry (right).

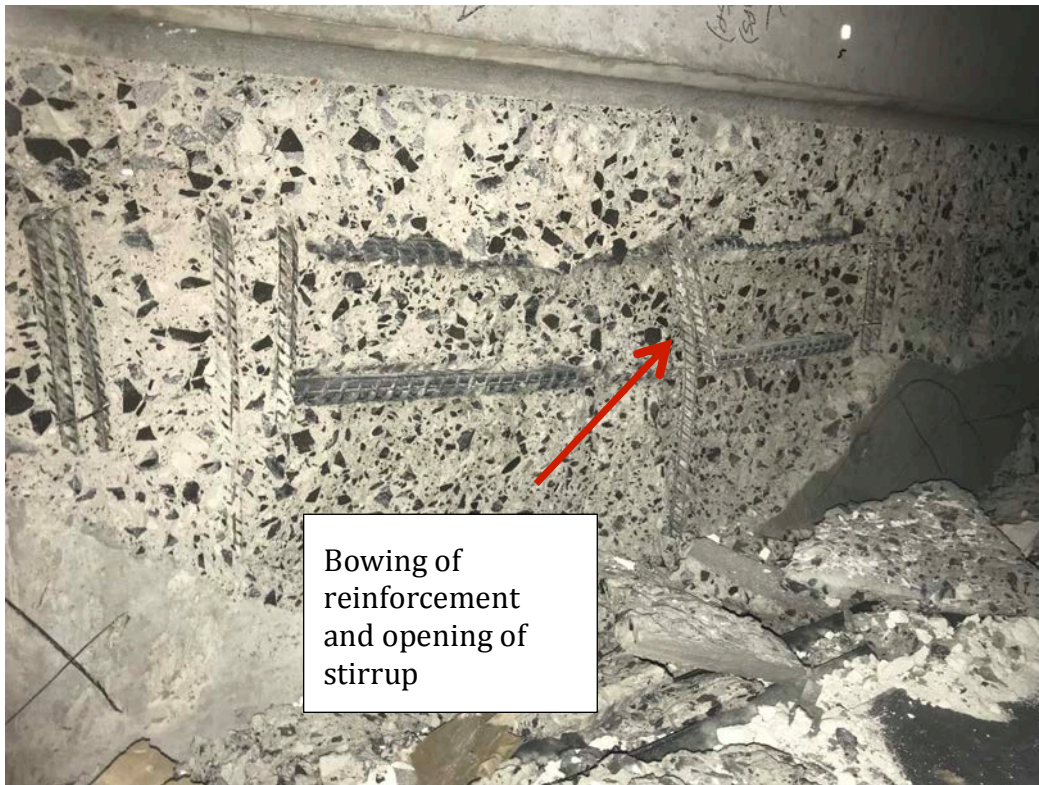
Figure 15. Damage in hob beam at Level 4 above column C34 showing bowing of reinforcement and opening of stirrup.

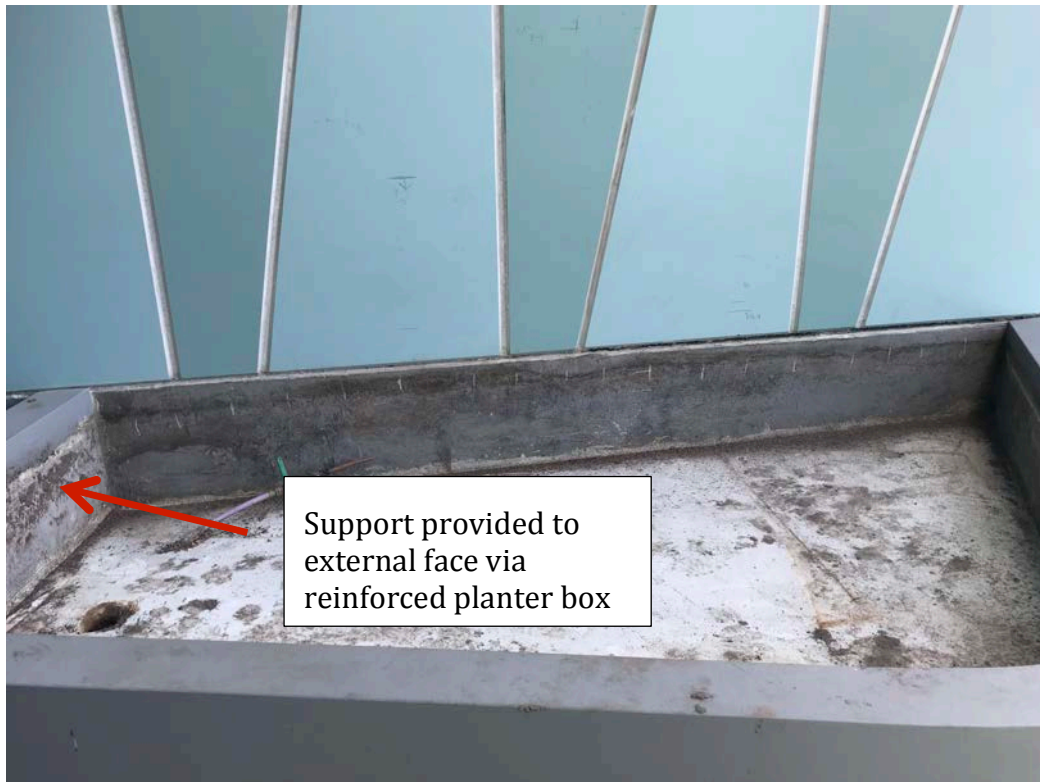
Figure 16. Lateral support provided to hob-beams at outside elevation through reinforced planter box hob – Level 4 Grid Line A.

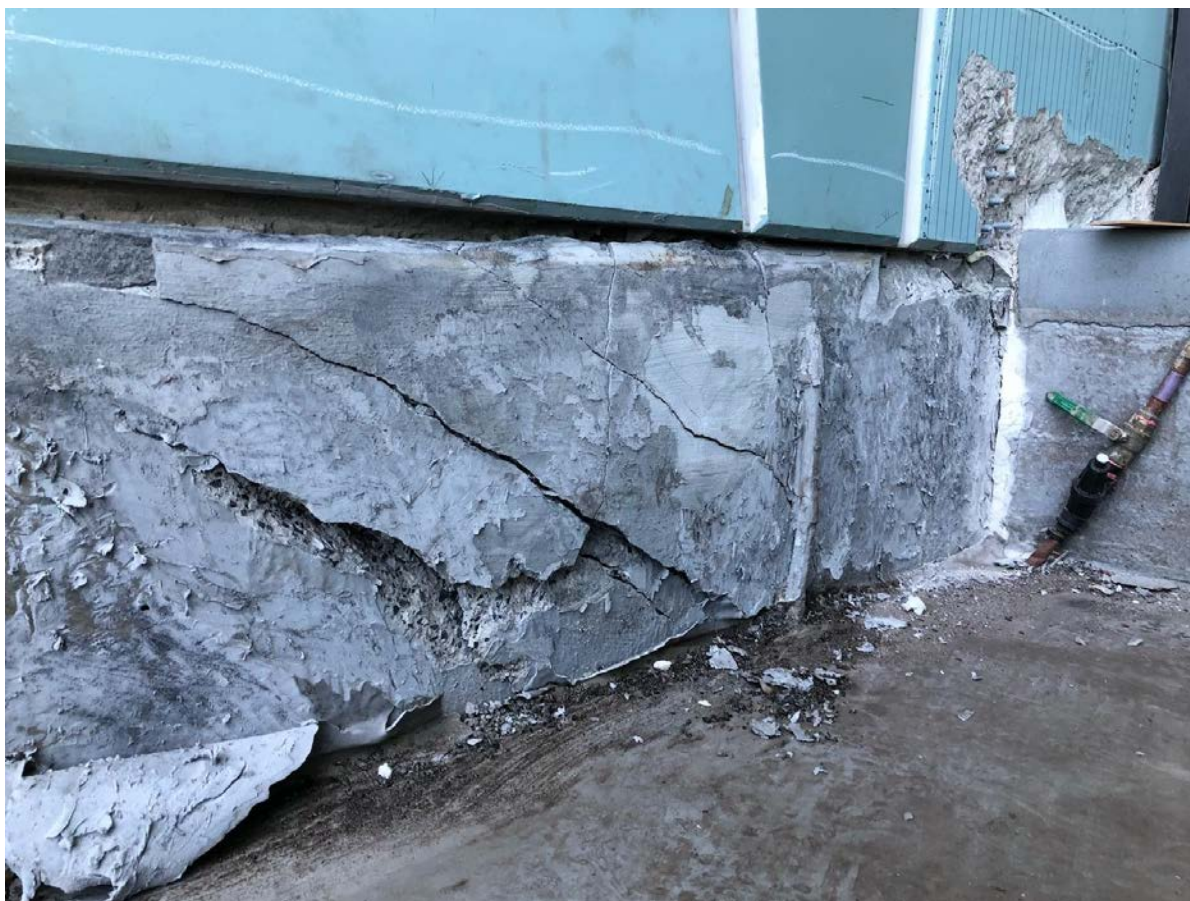
Figure 17. Hob beam at Level 10 in the vicinity of column C34 (outside) showing splitting along shear compression crack band lines.

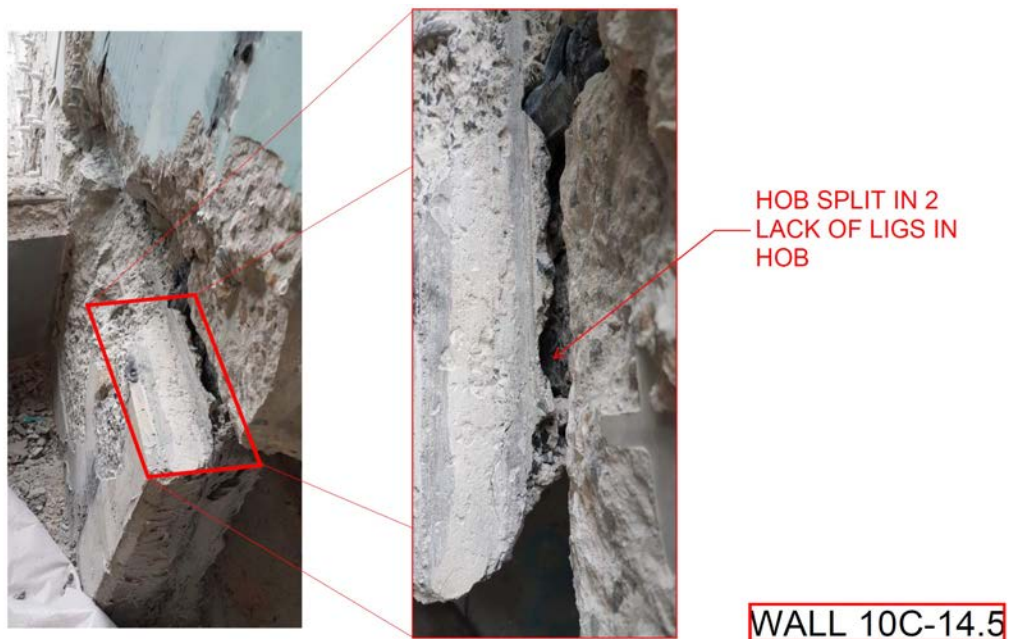
OVERVIEW OF HOB SPLIT

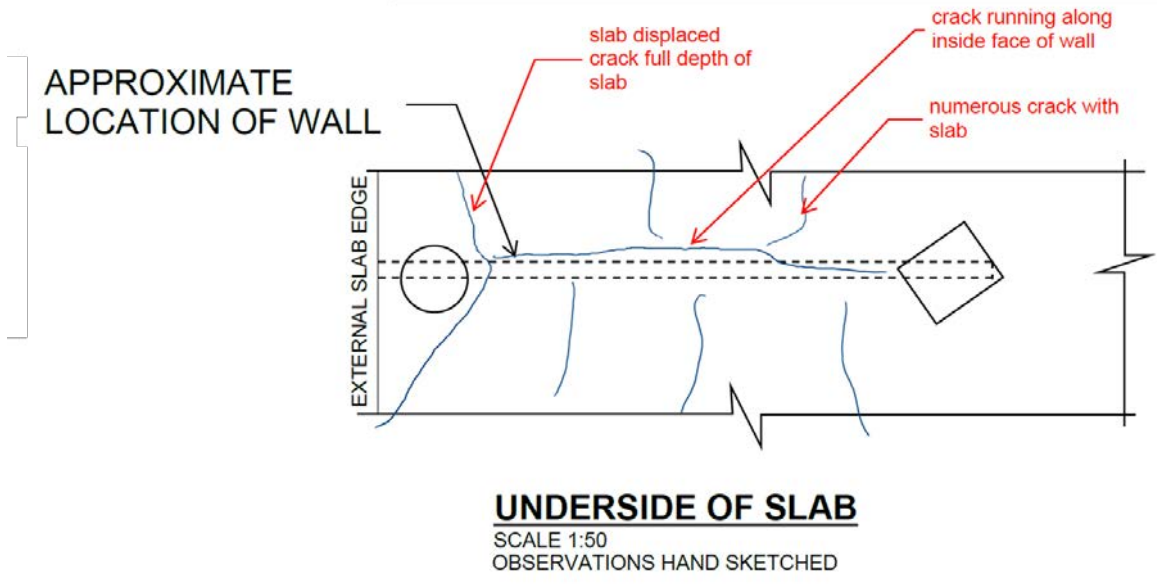
Figure 19. Drawing of the underside of Wall 10C-14.5 (Level 10 grid line C) documenting a splitting crack in the floor slab between columns C21 and at C38.

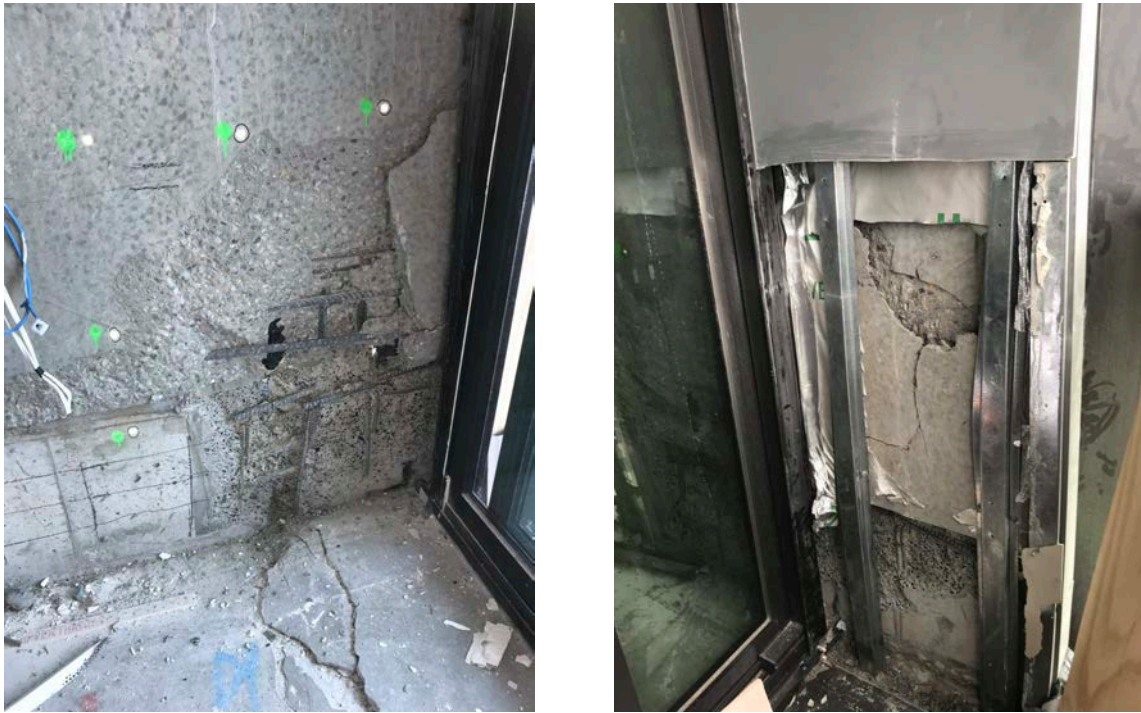
Figure 20. Hob-beam and precast wall panel at Level 10 in the vicinity of column C21 (apartment side) showing splitting of the precast panel and the damaged hob beam.
